The Q-Net™ Monthly

October-November-December 2012

A Legal Case about Improperly Reprocessed Flexible Endoscopes

Verdict: A jury finds a hospital "negligent" for improperly cleaning and disinfecting gastrointestinal endoscopes

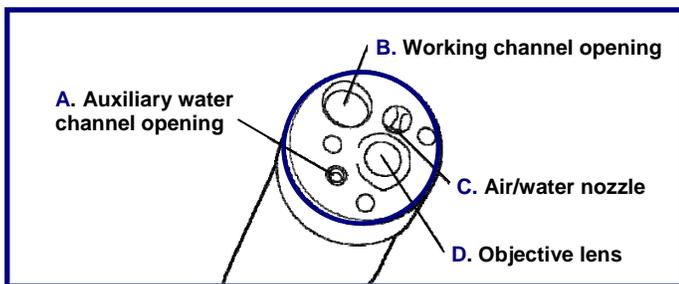
Auxiliary water channel: The auxiliary water channel of GI endoscopes (including of the two new colonoscopes used by *Hospital A* at the time of its breach; see: **main article**) is the conduit through which flows a pressurized stream of water designed to rinse the GI tract and enhance visibility of the examined mucosa. This channel's opening is displayed in **Figure 1**.

Figure 1. The openings of a gastrointestinal (GI) endoscope. Displayed are the openings, objective lens, and air/water nozzle, each of which is located at the GI endoscope’s distal tip (see: **Box A**). (Diagram by LFM, adapted from Olympus America with permission.⁸)

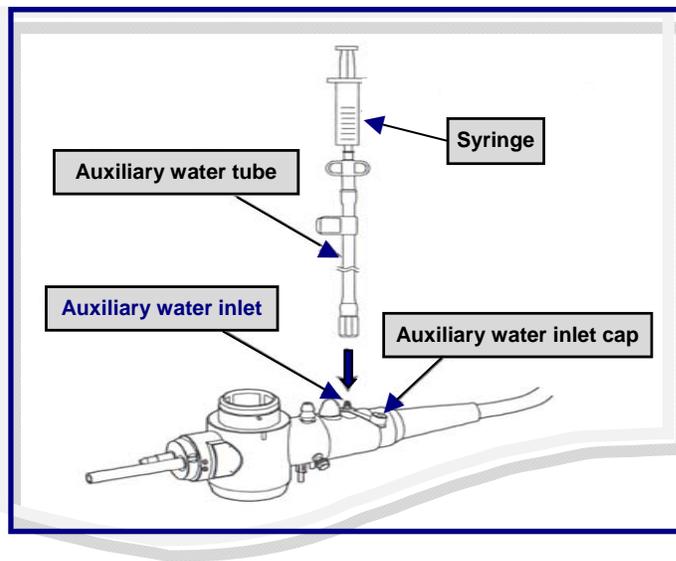
Figure 2. Location of the auxiliary water inlet. As displayed, the auxiliary water inlet of some models of Olympus America’s GI endoscopes, including the CF-Q160AL model that *Hospital A* used, is located on the GI endoscope’s light guide connector. For other models, however, this inlet may be located on the GI endoscope’s control section either above the suction valve (e.g., CF-1T140L) or just below the grip (e.g., GIF-2T100). (Diagram by LFM, adapted from Olympus America with permission.⁹)

obvious to untrained staff members. For some models of GI endoscopes, such as for *Hospital A's* two suspect colonoscopes, this inlet is located on the light guide connector (see: **Figures 2 and 3**), whereas for other models, this inlet may be located on another section of the GI endoscope—for example, on its control section (e.g., model: CF-1T140L; see: **Box A**).⁵

- *Identify* those GI endoscopes in inventory featuring an auxiliary water channel (or another specialized channel) and *confirm* the location of the auxiliary water inlet. *Ensure* that the auxiliary water channel is being reprocessed using the proper adapter (e.g., MAJ-855 tube).
 - › Caution is advised whenever models of GI endoscopes that do, and do not, feature an auxiliary water channel (or other specialty channel) are being used. These models are not necessarily easily distinguishable.
- Also, ensure that the GI endoscope's valves and other potentially contaminated internal and external surfaces are being properly reprocessed.

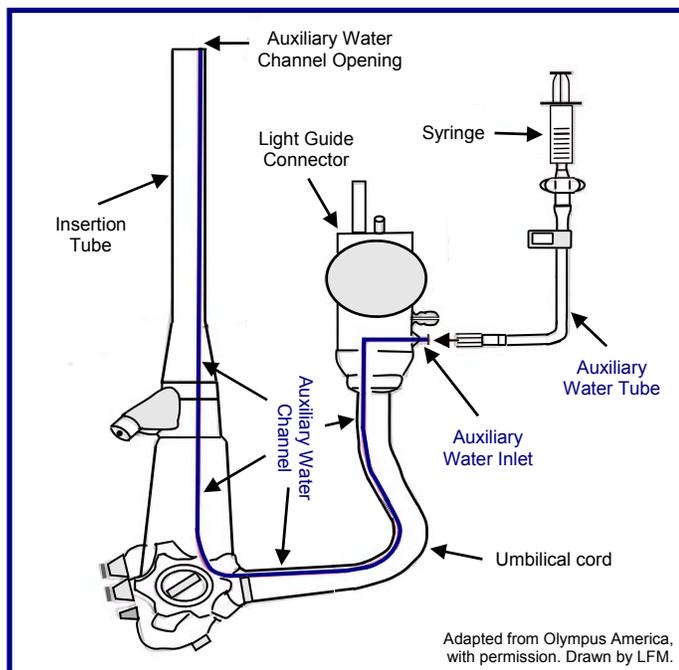
ROOT CAUSE OF THE BREACH: THE ROOT CAUSE of these two recently purchased colonoscopes remaining soiled with fecal matter, despite having been “reprocessed,” was the unwitting failure to have reprocessed the dedicated auxiliary water channel—whose function and intended use are described in **Box A** (also see: **Figure 1**).

Figure 3. Schematic of the GI endoscope's auxiliary water channel and inlet. Although for some GI endoscope models this channel traverses the insertion tube and umbilical cord (see diagram), for other models it may only traverse the GI endoscope's insertion tube.
